RL-TR-96-117
In-House Report
October 1996

ROME LABORATORY ANALYSIS OF COMPONENTS FOR ELECTRONIC TECHNOLOGIES FOR CLEANING IN 1996 AND BEYOND

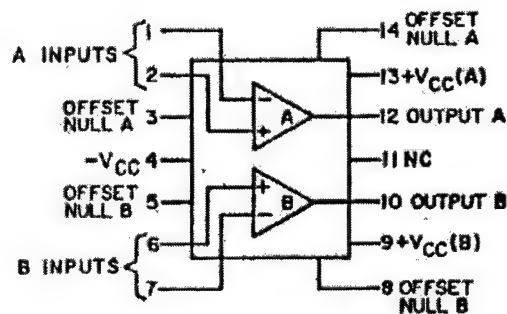
Figure 1: Package Pinout of LM747

The device package pinout is shown in Figure 1. This package contains two operational amplifiers and individual offset nulling circuitry.

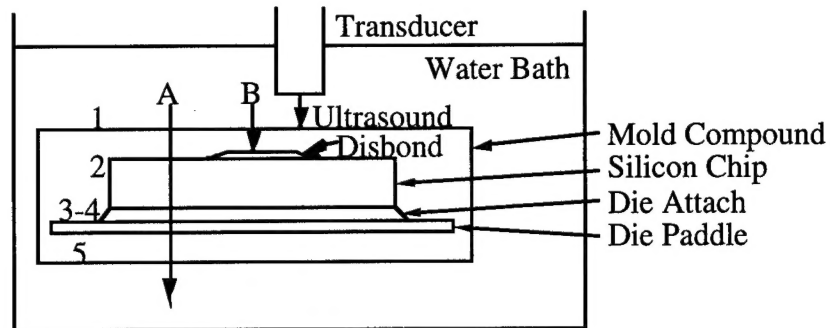
Plastic packages are typically analyzed using transducer frequencies between 10-30 MHz depending on the thickness of the package. Thick plastic packages result in attenuation loss of the ultrasound and difficulty using the higher frequencies. The image in Figure 1 is a schematic of a cross-section of a plastic package. Lines A and B are two ultrasound paths with the oscilloscope traces shown below. When ultrasound travels from a low to a high acoustic impedance material (see table), a positive echo results and vice versa for a high to low acoustic impedance interface. In trace A, the ultrasound travels from water to the mold compound which results in a positive echo. The next interface, mold compound/silicon die, also results in a positive echo. If we compare the second echoes from trace A and B, we notice a difference in the polarity. The second echo of trace B is negative due to the phase change of the ultrasound at the mold compound/disbond interface on the surface of the silicon die. Echoes 2, 3, and 4 for trace A are close together due to the acoustic velocity in silicon and echo 5 is small considering most of the ultrasound has been reflected at the previous interfaces. There aren't any echoes on trace B after echo 2 due to ultrasound being virtually impenetrable through a vacuum. Images in color or monochrome are produced from the amplitude and polarity of these traces and viewed on a CRT display.

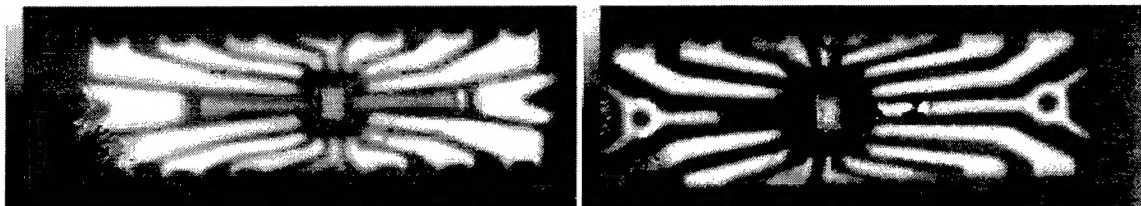
Figure 1. C-SAM of PLASTIC Device Figure 2. C-SAM of RWOH Device

PLASTIC vs RWOH: All the devices exhibited good bonding integrity at the lead frame, die surface and die paddle bottom. The RWOH devices have delaminations on the paddle surface around the die and the PLASTIC devices did not. However, the PLASTIC devices had a different paddle and lead frame than all of the other devices. In addition, the die paddle surface for all of the PEMs of the RWOH type was delaminated around the die. Figures 1 and 2 represent C-SAM images of each part type. The black area is a delamination at the mold compound/die paddle interface.

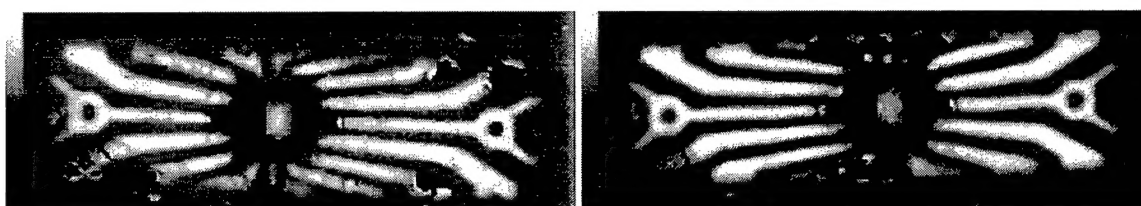
Figure 3. C-SAM of PLASTIC S Device Figure 4. C-SAM of RWOH S Device

PLASTIC S vs RWOH S: The PLASTIC S devices had more delamination than the RWOH S devices with the exception of the CONTROL device. However, there aren't enough devices to say if the RWOH devices would be more reliable. A lot of the devices exhibited delamination along the lead frame for pins 3, 4, 5, 10, 11 and 12 which is the shortest pathway to the die surface from outside the package. Figures 3 and 4 represent C-SAM images of each part type. The black areas are delaminations at the mold compound/lead frame or mold compound/die paddle interface.

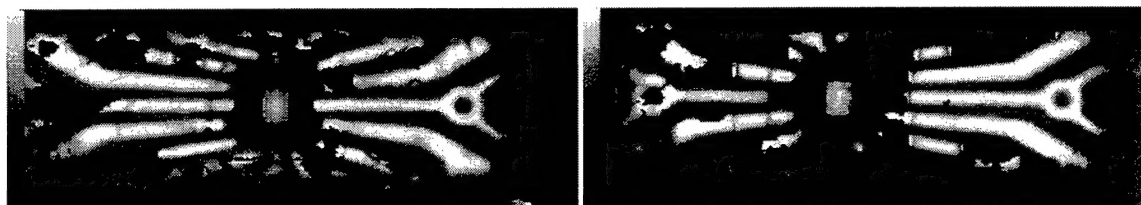
Figure 5. C-SAM of PLASTIC A Device Figure 6. C-SAM of RWOH A Device

PLASTIC A vs RWOH A: The PLASTIC A and RWOH A devices exhibited the most delamination of all the devices. Many of the devices exhibited delamination along the lead frame for pins 3, 4, 5, 10, 11 and 12 which is the shortest pathway to the die surface from outside the package. This delamination could have a significant reliability effect if contamination can find its way to the die surface. Figures 5 and 6 represent C-SAM images of each part type. The black areas are delaminations at the mold compound/lead frame or mold compound/die paddle interface.
